**MEMORANDUM**

**RE:** Lake Stevens Outlet Stream  
Pedestrian Bridge Crossing

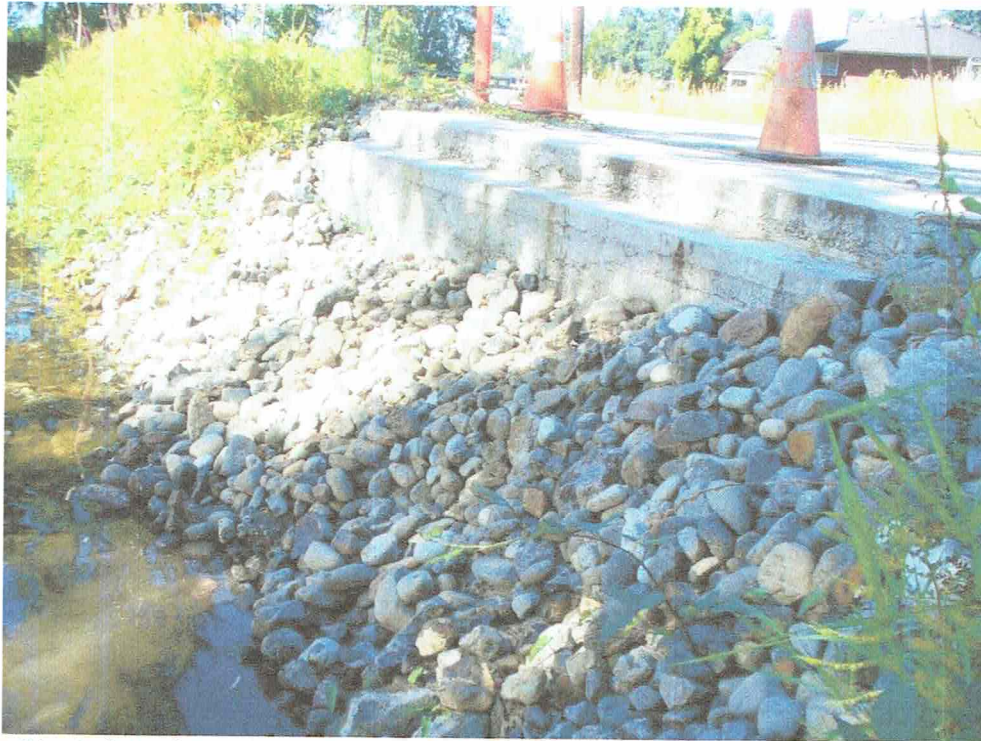
Topographic survey indicates that the in-place bridge footing is slightly outside the flagged and mapped ordinary high water (OHW) line horizontally (see attached drawing). Furthermore, City staff have indicated that the height of the footing is 18-inches which puts the base of the footing outside and above OHW. However, some of the cobbles that were placed for erosion control on the left bank ended up below OHW (see attached drawing and photo).

Greg Johnston, Senior Fisheries Biologist of The Watershed Company, inspected the footings and cobbles and determined that the cobbles are rounded and graded (2-8 inches) such that they are not creating a hazard to fish and, in fact, may provide some habitat value. The outlet channel generally exhibits a substrate composition which is too-fine-grained for salmonid fish spawning, and the placed rounded rock at the crossing location could make a contribution to substrate for that function. During a recent site visit on July 12, 2021, with representatives of Washington Department of Fish and Wildlife (WDFW), the Tulalip Tribes, the City of Lake Stevens (City), and The Watershed Company, WDFW and the Tribes both firmly objected to removal of large-gravel, rounded substrate in the vicinity of the Main Street crossing. Therefore, keeping the cobbles installed for the bridge footing would be consistent with keeping the gravel at Main Street.

Photo #1 – Left Bank Bridge Footing and Cobbles (photo taken by Greg Johnston on 7/20/21)

In conclusion, removing the bridge footings and re-constructing the exact same footings to meet the goals of the proposed pedestrian bridge, as stated above, would cause more impact to the stream and its habitat than leaving them in place. Similarly, removing the rounded cobble material would be more adverse than leaving the material as-is. The proposed bridge will have less than the prescribed 3-feet of clearance over the 100-year water surface; however, there is valid justification for the lower clearance.
